SPENCEVILLE MINE CLOSURE

Daniel Wanket, GEI Consultants, Inc.

Alberto Pujol, P.E., G.E., GEI Consultants, Inc.

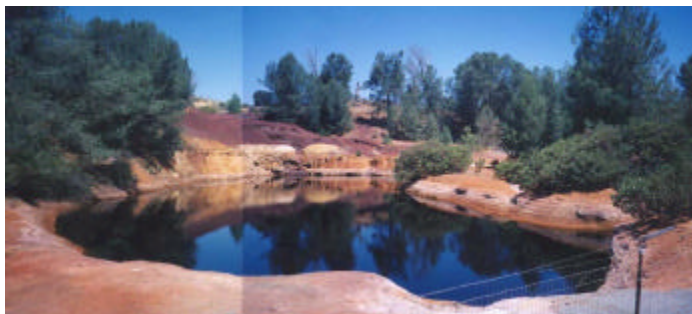
Photo 1 - Spenceville Mine pit

The Spenceville Mine site area encompasses approximately 10 acres bounded on the east and south by Little Dry Creek and Dry Creek, respectively. The mine site is located at altitudes ranging from 300 to 500 feet. In the central portion of the mine site was a lake created in a flooded open pit (Photo 1). The lake contained approximately 6 million gallons of acidic water (pH ~ 2.5). The pool's

surface area was approximately one-half acre, and the maximum depth of the lake was about 60 to 70 feet. Surrounding the pit on the west and north were piles of waste rock and roasted ore waste that were deposited on the side of a hill (Photo 2). Little Dry Creek flows south and is approximately 80 feet southeast of the mine pit. It joins Dry Creek approximately 400 feet south of the mine pit.

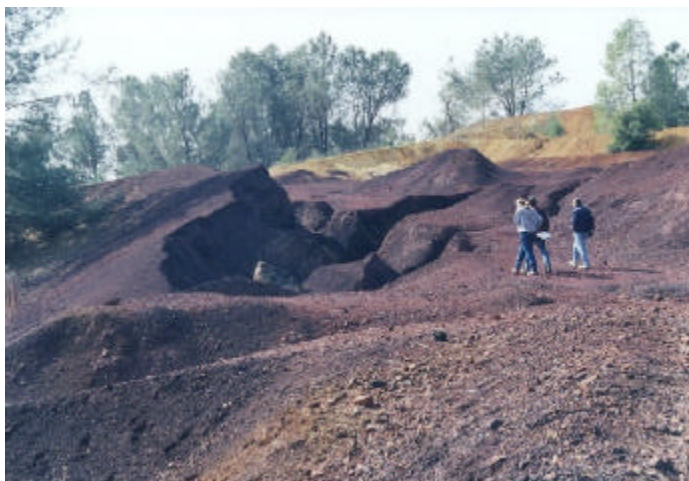
Photo 2 - Mine waste

The pit water had elevated concentrations of sulfate, iron, copper and zinc. Periodic surface water runoff and ground water seepage, from the mine waste material and the open pit lake, discharged low pH waters that were high in copper, zinc, iron and aluminum to adjacent Little Dry Creek (Photo 3). The concentration of copper and zinc in the discharge was sufficient to be detrimental to aquatic habitat. In addition, the proximity of the acidic open pit lake to a public access road created a public safety hazard.

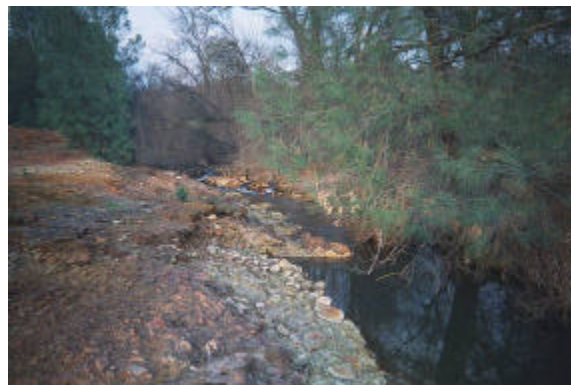
Photo 3 - Little Dry Creek adjacent to mine

Little Dry Creek received run-off leachate from the waste piles and overflow of water from the mine pit, resulting in significant loading of metals and acidic water to the stream. Although the affected area appeared to be mainly restricted to the section of Little Dry Creek adjacent to the mine site, both these factors decreased the suitability of the creek as habitat for aquatic receptors. In addition, Little Dry Creek near the mine site had a hard-bottom substrate of cemented rocks, very little overlying sediment, virtually no submerged aquatic vegetation, and very shallow water in most places. This combination of features contributed to the creek offering poor quality habitat for aquatic species.

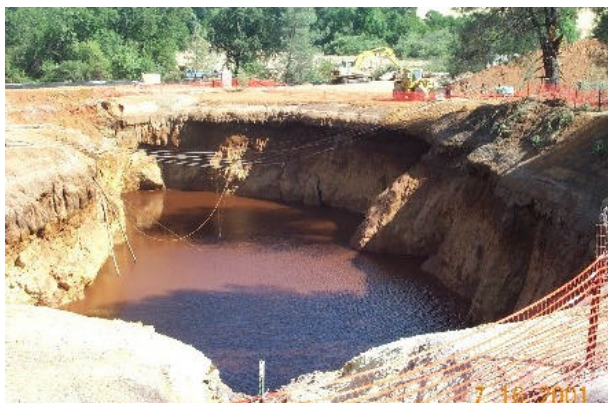
Photo 4 - Mine pit dewatering, July 16, 2001

Photos 4 and 5 show the pit in various stages of dewatering, and Photos 6 and 7 show the treatment plant during operation. Water from the pit was pumped at approximately 150 gallons per

minute into four 5,000-gallon reaction tanks from three pumps placed in the pit at 10, 25, and 45 feet below the water surface, respectively. The use of multiple pumps allowed blending of water to maintain consistent influent chemistry. Once in the plant, gravity flow was used to forward process water from one treatment unit to the next. In the first main reactor, an air line aerated the pit water to ensure that any ferrous iron existing under anaerobic conditions in the pit was converted to ferric iron, which is amenable to removal via neutralization. Neutralization in this reactor was achieved by the addition of hydrated lime slurry (30 % $\text{Ca}(\text{OH})_2$) to pit water in the well-mixed, aerated tank. A pH controlled lime pump was used to maintain tank pH at approximately 7.5, which is the titration endpoint that provides minimum solubility of the constituents of concern.

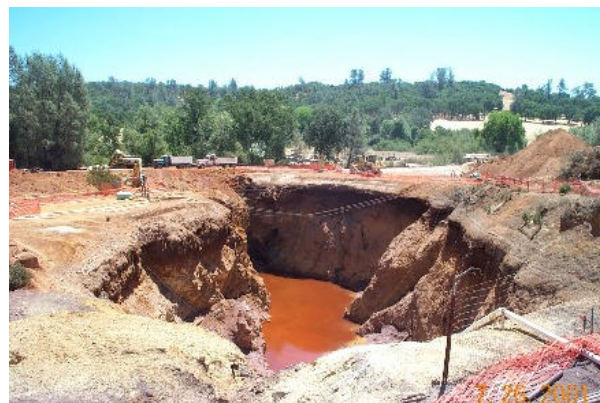
Photo 5 - Mine pit dewatering, July 26, 2001

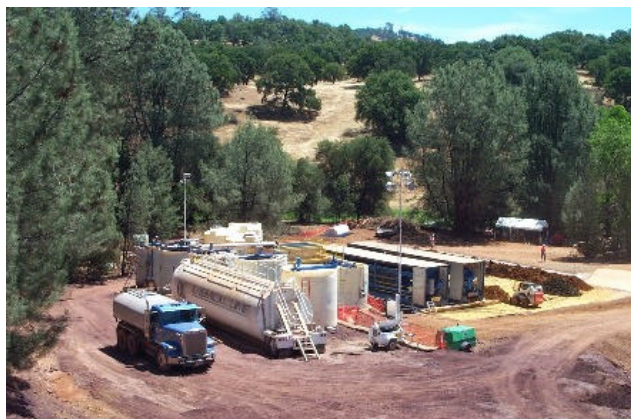
Photo 6 - Treatment plant

Effluent from the main reactor tanks drained into a 1,000-gallon flocculation/coagulation tank. In this tank, polymer that aids in the solidification and formation of easily filterable flocs was added to the reaction slurry containing neutralized water and metal hydroxide solids. After addition of polymer in the flash mixing chamber occurred, the mixture entered the gently mixed main tank for coagulation.

Coagulation tank effluent drained into an upright 5,000 gallon clarifier with removable lamella plates. In the clarifier, metal hydroxide solids settled and drained out the bottom. Clean, treated water overflowed out the top and was collected in a pH adjustment tank and then to a 500,000 gallon holding pond before being pumped to the land application area for discharge.

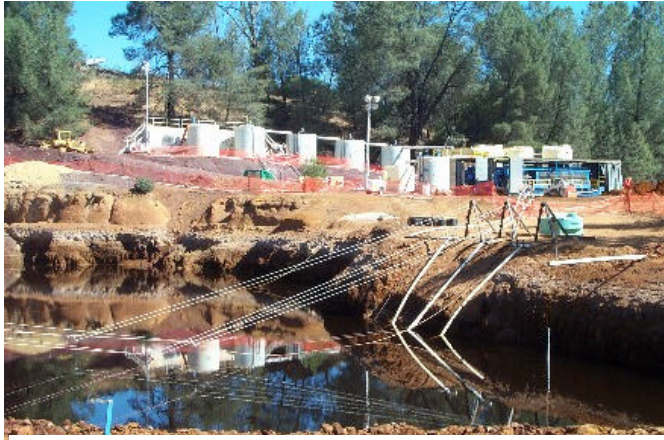
Photo 7 - Treatment plant and pit dewatering

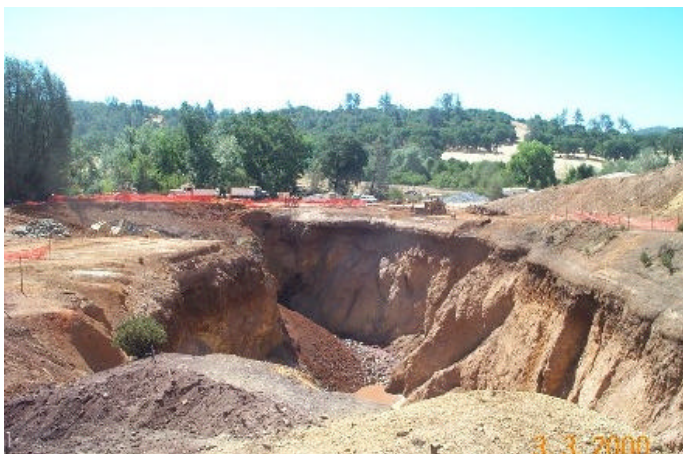
Photo 8 - Pit access ramp

Initial access into the dewatered pit was via an excavated ramp on the east rim of the pit. The ramp was excavated about half way down to the pit bottom, at which point a temporary fill of lime treated mine waste and excavation rubble was placed from the bottom of the excavation to the floor of the pit (Photo 8). Prior to beginning excavation of the pit bottom sediments, a large crane with a clamshell bucket was mobilized to remove several vehicles and other debris that were found at the bottom of the pit. After removal of the debris, excavation and treatment of pit bottom sediments began the first week of August 2001. While excavating the pit bottom sediments, the depth to a hard rock bottom was found to be significantly deeper than originally anticipated. Several test pits were dug into the pit sediments to determine the characteristics and estimate the depth of material in the bottom of the pit. Each test pit exposed a layer of hematite mine waste and/or fill material used for construction of the pit ramp, overlying a deposit of non-reactive metavolcanic rubble of undetermined depth. To address the unanticipated thick deposit of rubble on the pit floor, the pit bottom sediments were removed and the upper two feet of coarse rubble material were replaced with a two-foot-thick layer of compacted crushed limestone (Photo 9). The crushed limestone layer provided a base for placing the treated mine waste, and provided buffering for potential migration of acidic water into the pit.

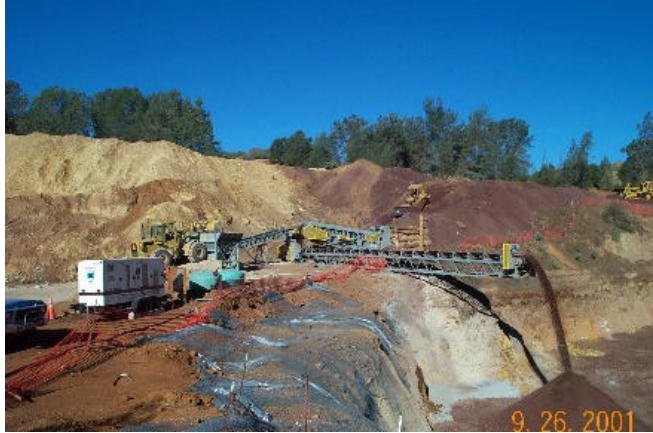
Photo 10 - Mine waste placement with conveyor

After treatment of the pit bottom sediments, placement of treated mine waste began. A conveyor system was set up for conveying the mine waste and lime into the pit (Photo 10). The conveyor system consisted of two sets of traps, motors and conveyors, one for the mine waste and the other for the lime. The two conveyors discharged onto a main conveyor, which transported the mixed mine waste and lime into the pit. A water spray nozzle was located at the end of the main conveyor to minimize dust generation as the material dropped into the pit. The speed of each conveyor was calibrated to obtain the proper lime dosage for each material. The lime and mine waste were further mixed at the bottom of the pit by dozers. The dozers spread the treated mine waste in 8-inch to one-foot lifts, and each lift was compacted with a sheepsfoot roller. Treated mine waste was

compacted to 95% of the maximum dry density as determined by ASTM D698. Once the elevation of the treated mine waste in the pit approached the elevation of the pit rim, the conveyor system was removed and the mine waste and lime were placed, mixed and spread in the pit with dump trucks and dozers (Photo 11). Since the volume of material placed in the pit exceeded the capacity of the pit, a mound of treated mine waste was constructed over the pit. After all the treated mine waste was

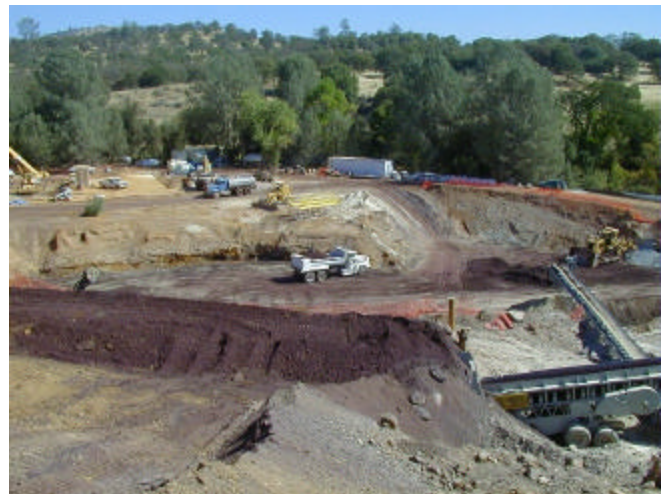
Photo 11 - Mine waste placement with trucks and dozers

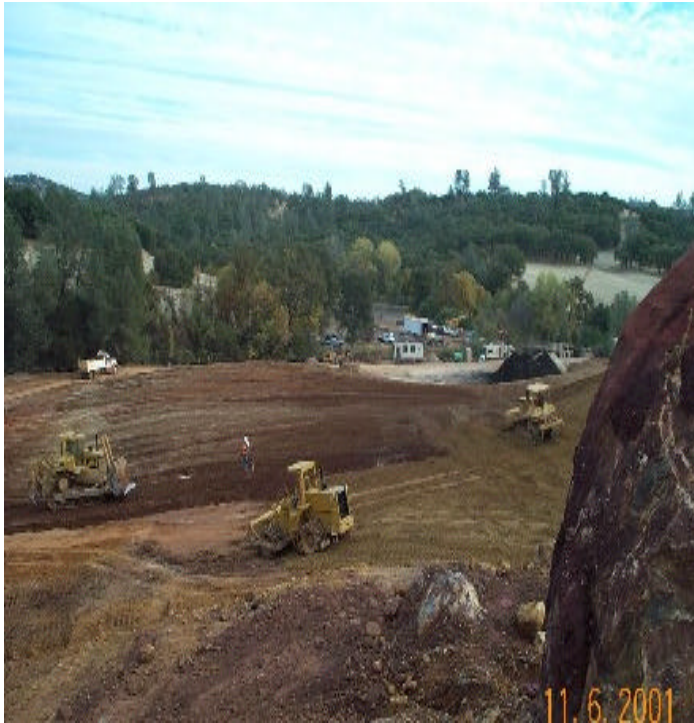
Photo 12 - Post-excavation grading

After the mine waste was excavated, and prior to placement of soil cover, the slopes of the excavated surfaces were regraded locally. The slopes were graded to 3 horizontal to 1 vertical (3H:1V) or flatter to reduce erosion, facilitate revegetation, and smoothly merge the topography of the regraded site with the adjacent land. In steep areas, or areas which had an abrupt change in topography, clean fill from a borrow area was placed to flatten the slopes and provide a smooth topographic transition (Photo 12).

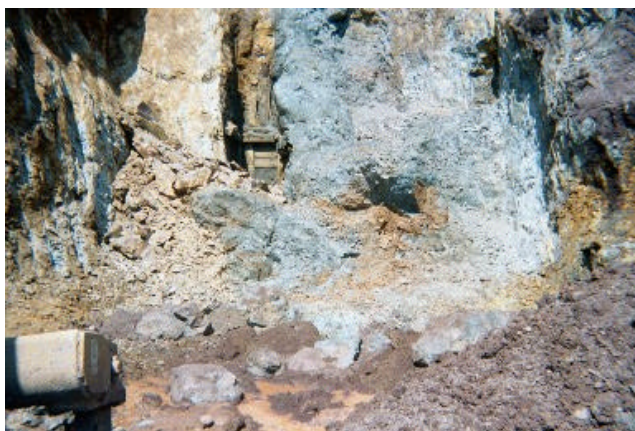
Photo 13 - Shaft and adit in mine pit

Dewatering of the pit revealed several old adits and a shaft within the pit (Photo 13). It was determined that a mixture of 60 % limestone and 40% fresh bentonite (by volume) would be used to stabilize the adits and shaft. The purpose of the bentonite was to minimize seepage of potentially acid water into the pit, while the purpose of the limestone was to buffer any seepage that does move into the pit.

The limestone/bentonite material was placed into each adit as deep as possible with an excavator bucket. The shaft was filled with quarry rock to about 20 feet below the rim of the shaft. The remainder of the shaft was filled with the 60/40 mix of limestone and bentonite. After remediation, the adits and shaft were buried with placement of the treated mine waste in the pit.

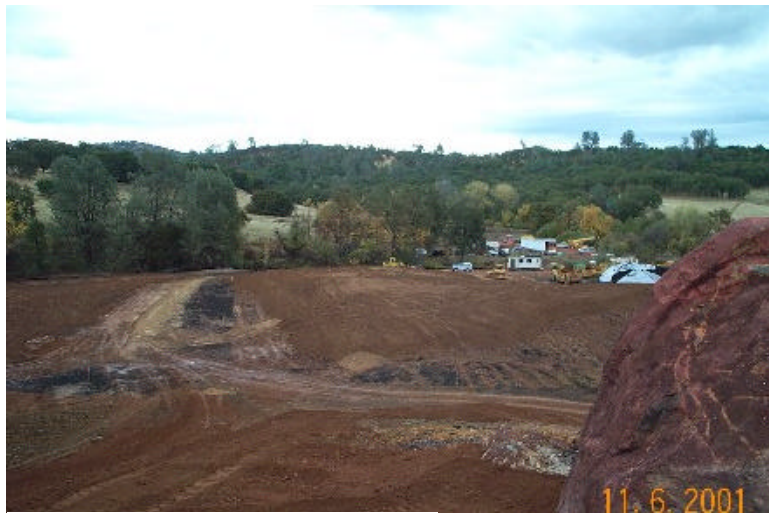
Photo 14 - Placement of soil cover

loaded and transported to the mine site using wheel-scrapers with a capacity of about 20 cy. The cover soil was spread at the mine site by dozers to the specified thickness, which was two-feet thick over the treated mine waste pile and the footprint of the former tailings piles, and one-foot thick in the areas which had disturbed native material (Photo 14).

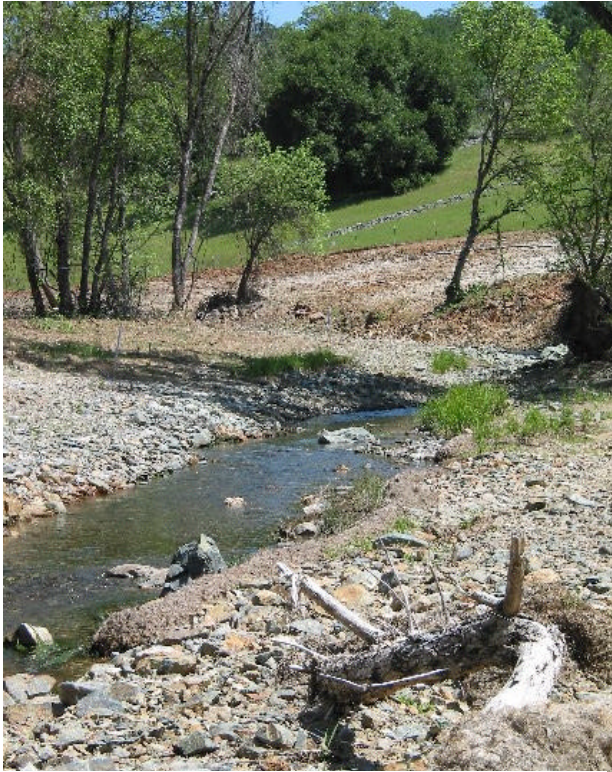
Photo 15 - Relocated Little Dry Creek

Based on a review of pre-mining site photos and a survey of the existing creek bed area, it was determined that the original pre-mining stream channel was east of the existing channel. Stream restoration thus included re-establishing the original stream channel. The construction work involved grading the stream and clearing the old channel before diversion barriers were removed to divert stream flows from the existing channel to the new channel. The altered streambed contains ponds, swales and large rocks to produce well-aerated water with numerous areas for establishment of pre-mining creek habitat (Photo 15). Re-colonization by benthic invertebrates from upstream locations following re-establishment of normal creek flow should result in re-population of the creek with a similar abundance and diversity of benthic organisms as present before mining occurred.

Prior to excavation of the new channel, the existing channel of Little Dry Creek adjacent to the mine site was temporarily diverted as part of the remedial work to permit removal of iron and aluminum hydroxide sediments and evaporative salts from the creek bed. Removal was performed by washing the creek bed with high-pressure water jets. After cleaning and excavation of the new channel, the old channel was filled with clean fill and lime rock to ensure neutralization of seeps in the channel and to provide a good growth medium for new vegetation.

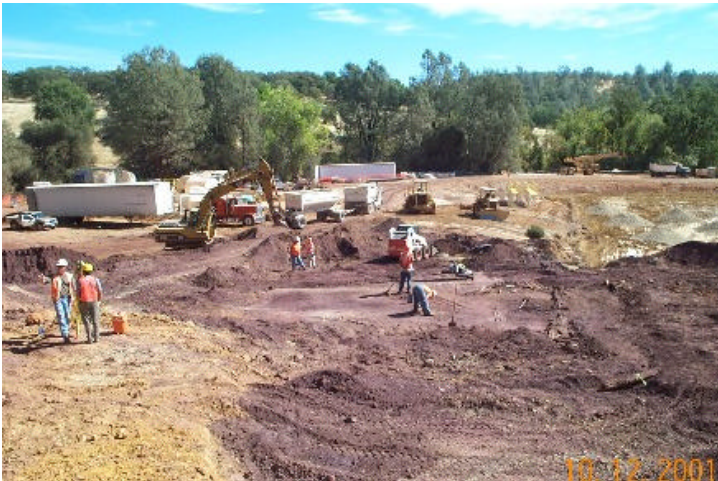
Photo 16 - Archaeological investigations during excavation

Archaeological investigations were conducted from June 2001 to November 2001 (Photo 16). These investigations revealed eighteen historical features or elements of features. Archaeological findings included a 126 foot by 30 foot concrete platform, which apparently was used to dry copper

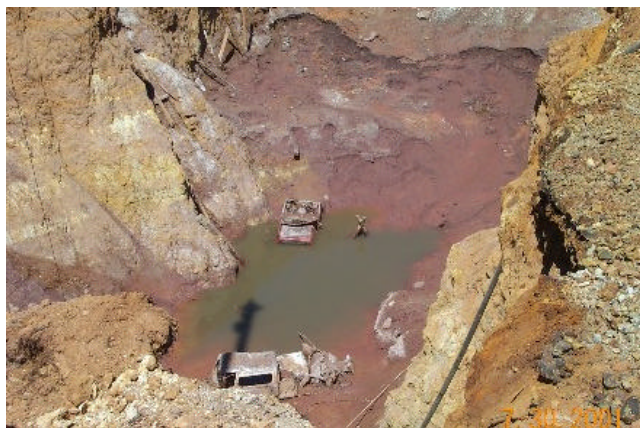
Photo 17 - Vehicles at bottom of pit

Subsequent activities addressed the potential for UXO and CWM in the mine pit, and the possibility of uncovering UXO during excavation of cover soil from the borrow areas. After the pit was dewatered, a visual and geophysical inspection of the pit bottom was conducted (Photo 17). UXO support continued during excavation and treatment of the pit bottom sediments, and during stripping of the borrow areas for cover soil. While several ordnance related items were retrieved, including an M-1 clip, M-4 105 shell casing, parachutes, and a site tube from gas tanks, no live ordnances or CWM were discovered.

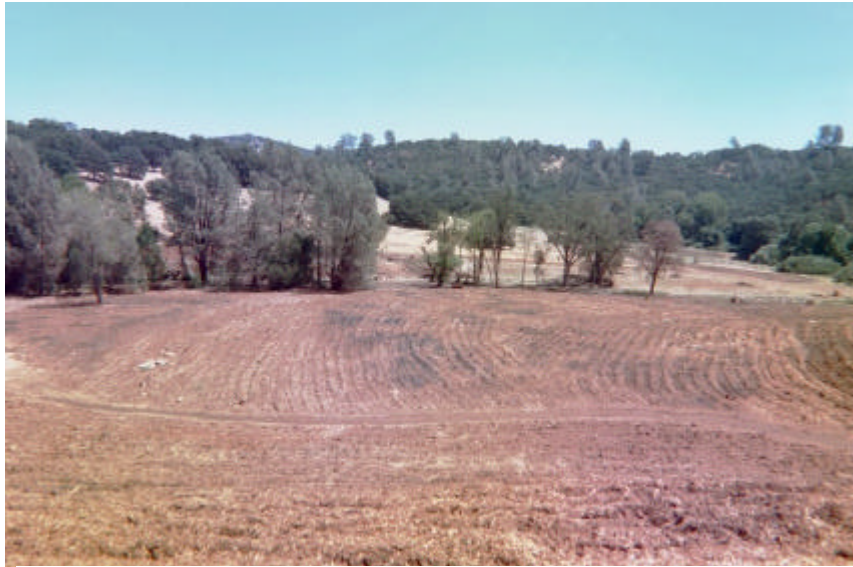
Photo 18 - Final site grading – note that filled mine pit is in center of photo

The Spenceville Mine Closure proceeded on schedule and, as of July 2002, is nearly finished (Photo 18). The only remaining portions of the closure are the drilling of two down-gradient groundwater monitoring wells, and revegetation of a portion of the site. In all, the project was completed in about 18 months and accomplished the following:
